Is Water Flowing Unrestricted from the Boiler to the Level Indicator?

The consequences of a restricted water feed pipe to a primary or secondary low-water device can have devastating results.

By Jim Kolbus

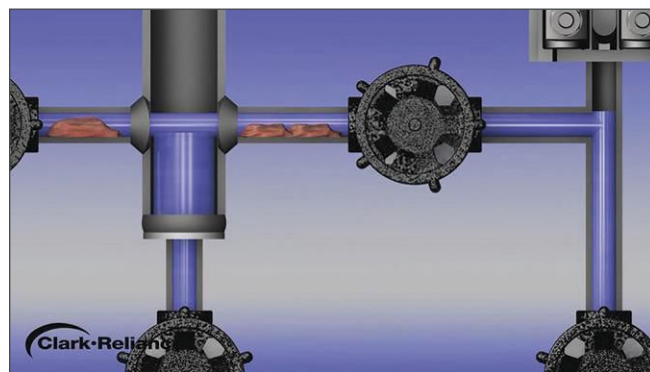
The concern for sediment buildup is most likely to occur in the water line or isolation valves, resulting from particulate in the boiler water or from erosion of the boiler internals or external piping over time. The risk is minimal in the steam piping.

Figure 2 illustrates how sediment can collect in water outlet piping.

Figure 2. A sediment buildup simulation.

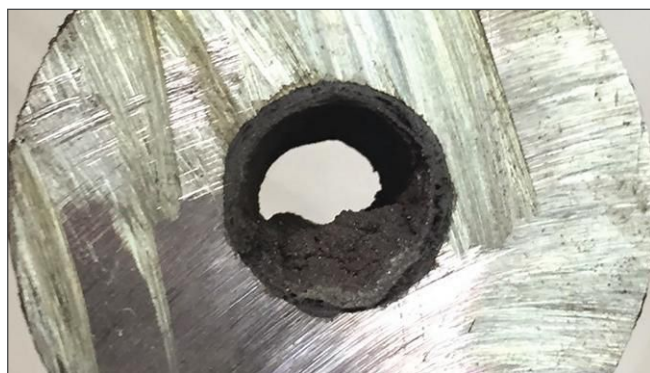
Figure 3. Actual blockage after punching through it.

The image in Figure 3 was taken after the actual blockage in the inlet area of a water isolation was discovered and punched out. This section of the valve was removed for educational purposes. Restrictions of this nature can often be discovered by removing the valve operating stem and physically rodding through the valve into the depth of the inlet connection.

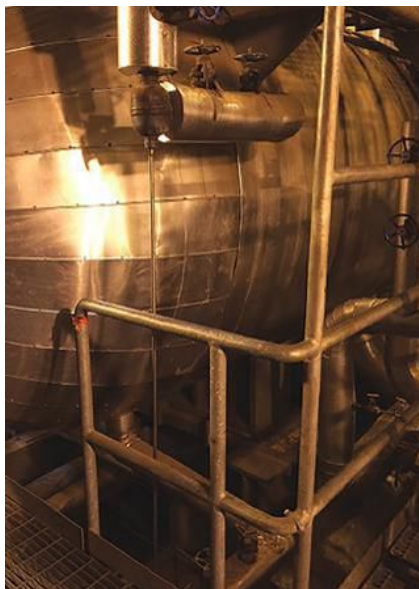
Figure 4. Upper connection tubing on a differential pressure transmitter.

In addition, any sensing lines installed on differential pressure transmitters may become restricted over time and should be blown out during inspections. The relatively small size of the tubing on a typical differential pressure transmitter installation is visible in Figures 4 and 5.

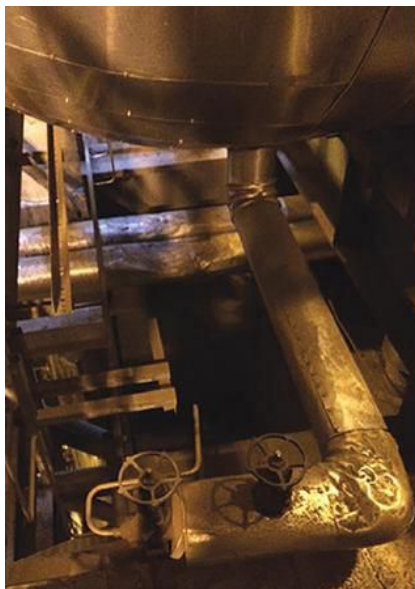
Figure 5. Lower connection tubing on a differential pressure transmitter.
