## Case Study

**TOPIC:** Water and Particulate Contamination In Steam Turbine Lube Oil Reservoir

**LOCATION:** Power Plant In Nursery, Texas

**DATE:** February 2, 2012

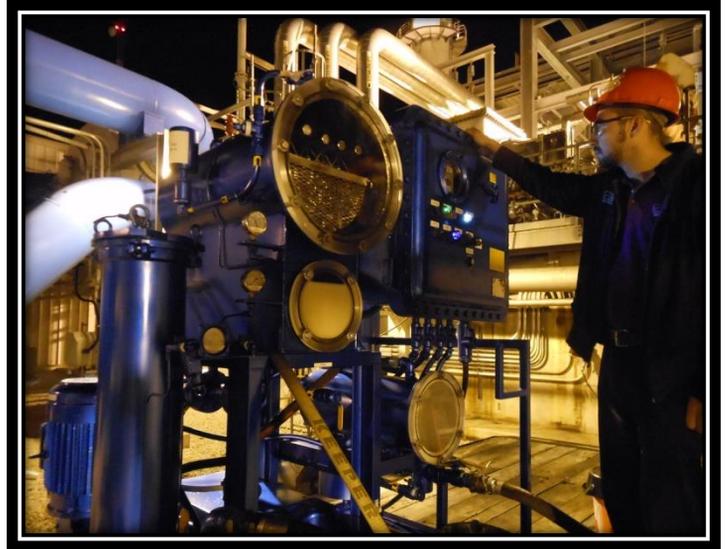
**Solution:** A VDOPS uses state-of-the-art filtration technology to lower water in oil concentrations in turbine oils to 45 PPM or lower. The system also uses the latest filtration media to lower particulate contamination to meet or exceed new oil cleanliness specifications, typically at ISO 16/13/10 or lower. The VDOPS systems are simple to operate and only use electricity to remove particulate, dissolved gases and water from oils. The systems are virtually maintenance free and are designed to run continuously 24/7 in any environment.

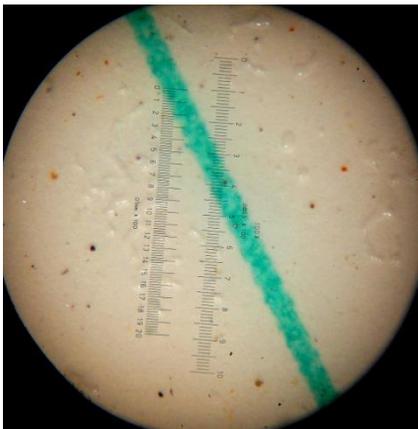
**Pre-Filtration/Dehydration ISO Cleanliness Code**

**18-16-14**

**Particle Size**

**Range of Particles /ml**

>4mm  
>6mm  
>14mm

2,500-1,300  
640-320  
150-80

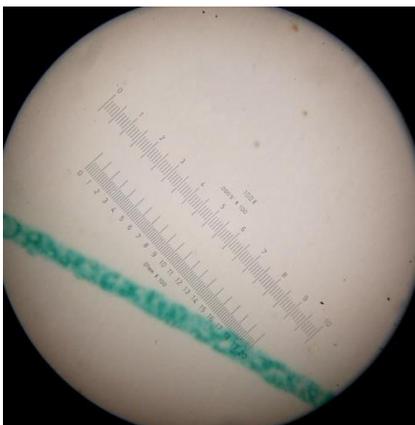
**Final Sample ISO Cleanliness Code**

**15-13-10**

**Particle Size**

**Range of Particles /ml**

>4mm  
>6mm  
>14mm

320-150  
80-40  
20-10

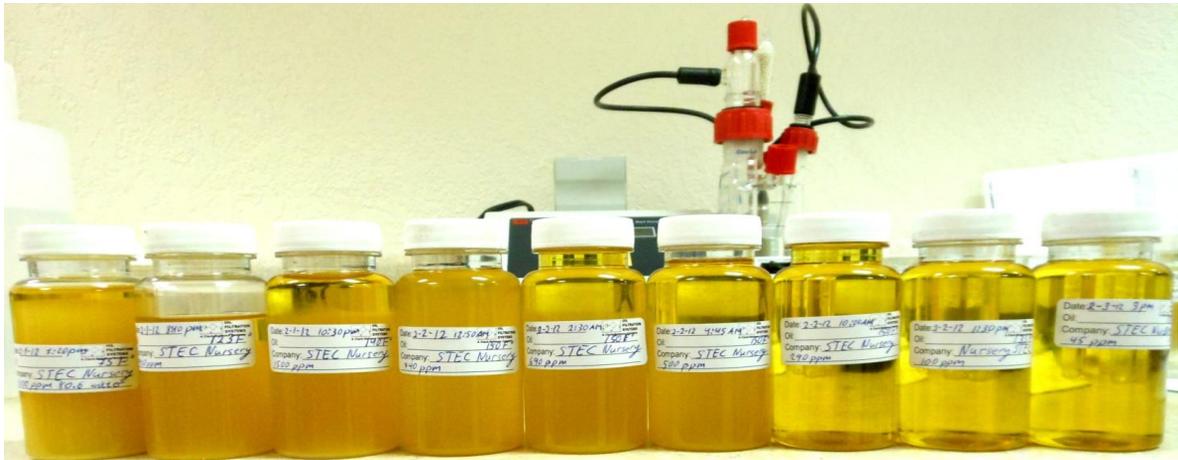
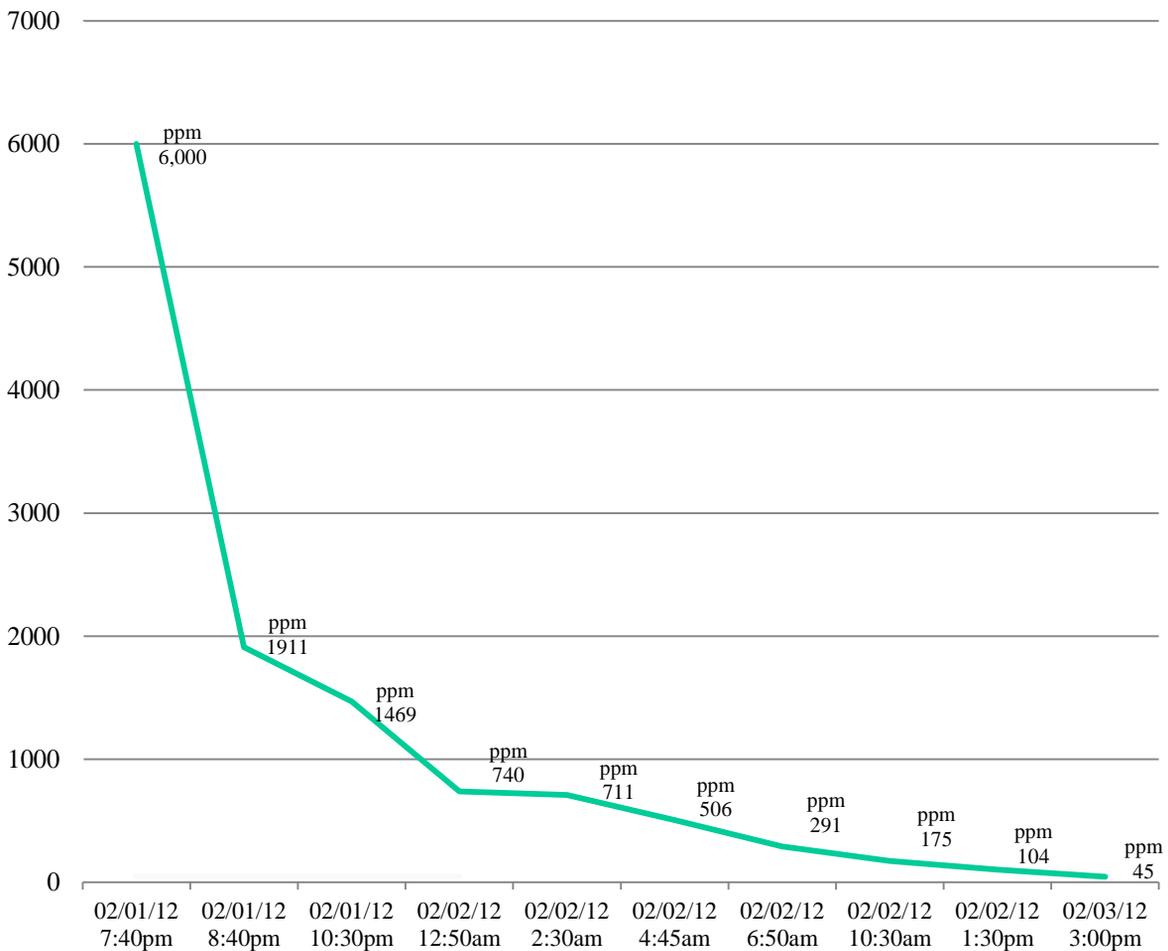
# Work Progress Chart

**Results:** Work started on Wednesday, February 1, and was completed on Friday, February 3. The VDOPS system ran for approximately 36 hours straight, while water levels dropped from over 6,000 PPM to under 45 PPM (see page four (4) for oil analysis water reduction graph). Particulate was lowered from 18/16/14 to 15/13/10; see page (3) for Particulate Removal / Oil Analysis Results. These results were verified by an on-sight Portable Fluid Analysis Kit (PFAK). The PFAK enabled our technicians to know how fast the system was cleaning the fluid and enabled the customer to visually see the results. This on-sight awareness brought confidence to STEC because they could also see the results in real-time and be part of the oil analysis process. STEC witnessed the system purifying the oil both by viewing the VDOPS in operation and also by an On-Sight Fluid Analysis Kit.
